Manhole Inspection Summary

Manhole # S11S__009MH

Location Address: **903 Desoto Rd**

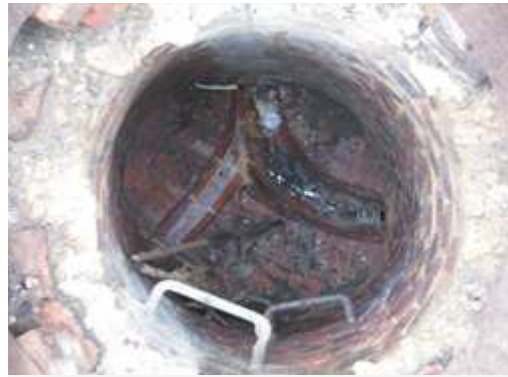
Top View

top view of MH, Debris in the mh

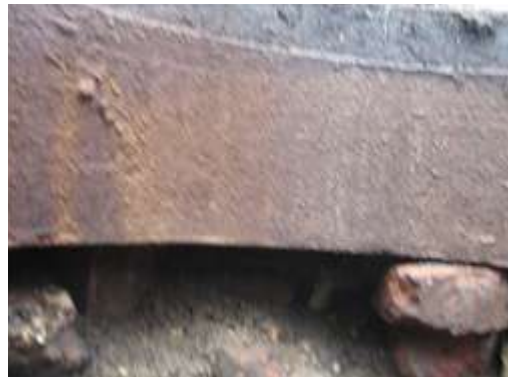
Defect 3

chimney loose bricks

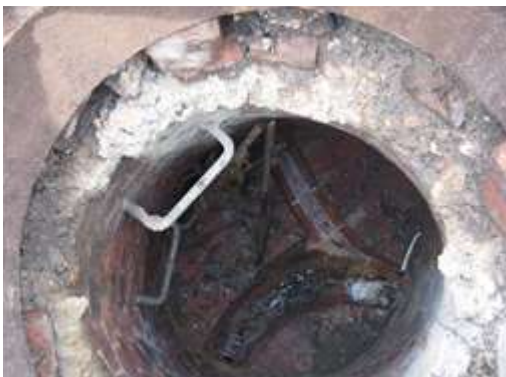
Defect 5

Pic #2 of offset in MH and debris

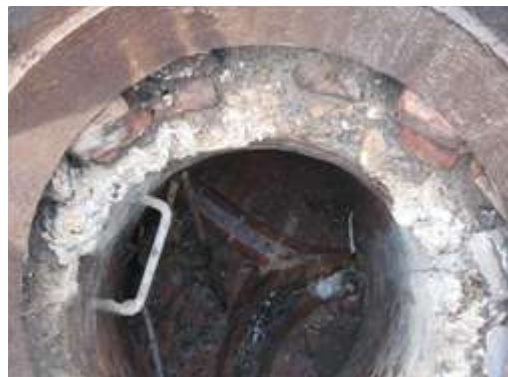
Defect 4

offset of lid from the chimney, frame leaks,

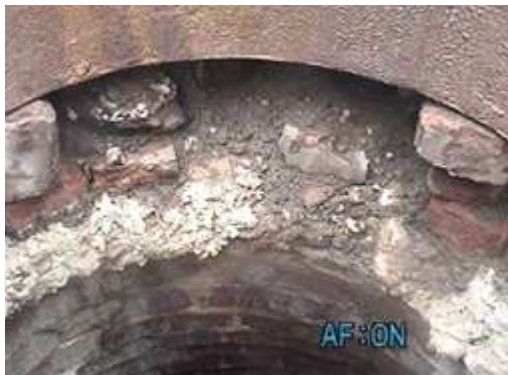
Defect 2

missing bricks at chimney and deteriorated chimney/evidence of infiltration in MH

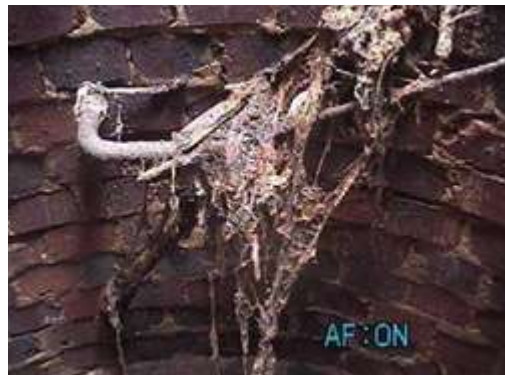
Defect 1

surcharge evidence on steps

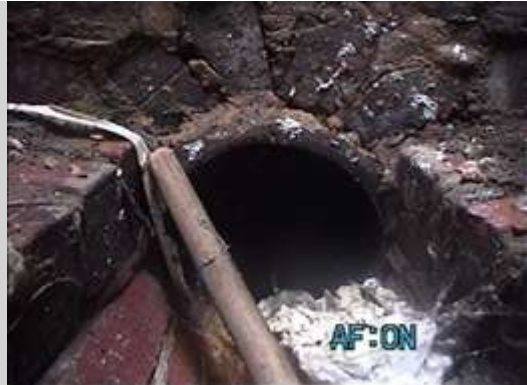
12 O'Clock Outflow

Pipe Height: **8.4** (in.) Rod and Bar (Angled)
Pipe Material: **Clay** ☐ Pipe Lined
Invert Depth: **7.70** (ft.) Flow Characteristics: **None**
Deposits: ☒ None ☐ Mud ☐ Sludge ☐ Debris ☐ Grease
Silt Depth: **0** (in.) Deposits Extent:
Infiltration: **Evidence** Pipe Seal Cond: **Unknown**

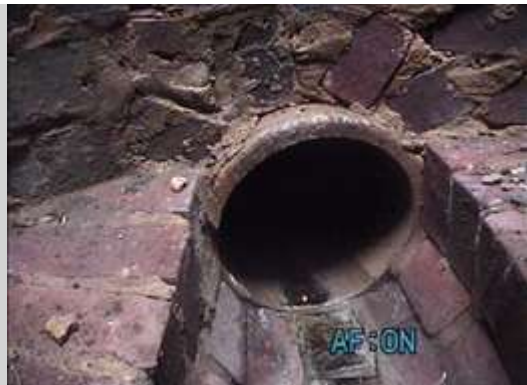
4 O'Clock Inflow

Pipe Height: **8.4** (in.) Rod and Bar (Angled)
Pipe Material: **Clay** ☐ Pipe Lined
Invert Depth: **7.50** (ft.) Flow Characteristics: **None**
Deposits: ☒ None ☐ Mud ☐ Sludge ☐ Debris ☐ Grease
Silt Depth: **0** (in.) Deposits Extent:
Infiltration: **Evidence** Pipe Seal Cond: **Unknown**

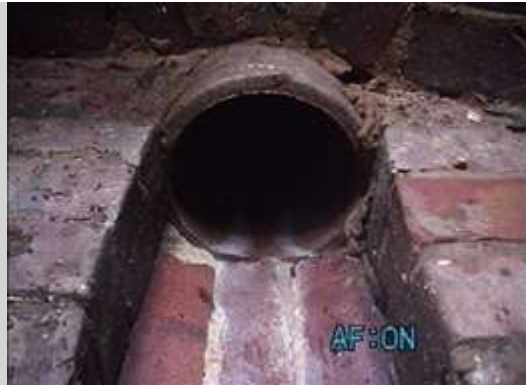
8 O'Clock Inflow

Infiltration: **Evidence**
